Manhole Inspection Summary

Manhole # S37G__034MH

Insp Date: **8/18/08 11:55 AM**

Location Address: **500 e baltimore st**

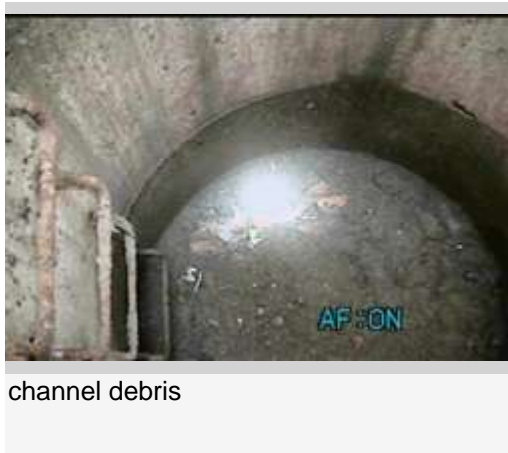
Defect 2

Condition: ☐ Sound ☐ Cracked ☐ Root Intrusion ☐ Deteriorated ☐ Leaks ☒ **Debris**

channel debris

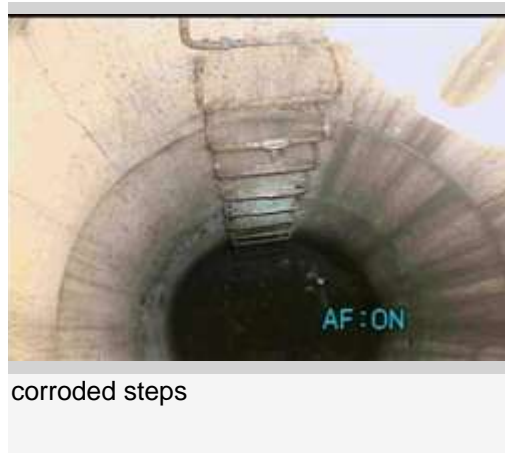
Defect 1

Count: **11** Missing: **0** ☒ **Corroded**

corroded steps

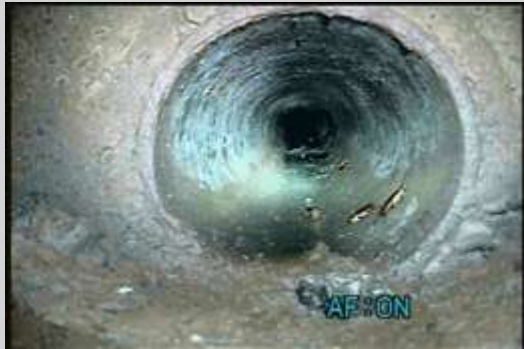
12 O'Clock Outflow

10 in. Circular Gravity Sewer
Pipe Out @ 12 O'Clock
